Pitfalls in Structural Dynamics

Dr. A. Ziegler; ZIEGLER CONSULTANTS, Zürich

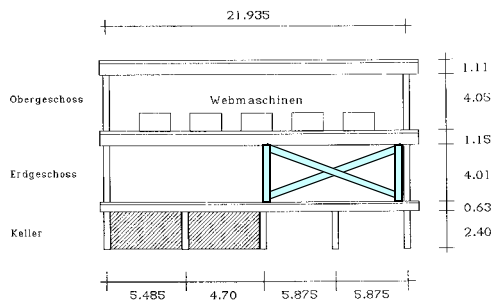
Fig. 1a Cross section of building, strengthened with steel trusses

He decided to strengthen the building by some heavy I-shape steel trusses (size HEM 300) as shown in Fig. 1.a. The result was disastrous. Instead of a reduction this strengthening brought a doubling of the horizontal vibrations with peak horizontal velocities reaching 20 mm/s. Employees complained about sea sickness. Machines in the area of highest vibrations received no proper attention anymore.

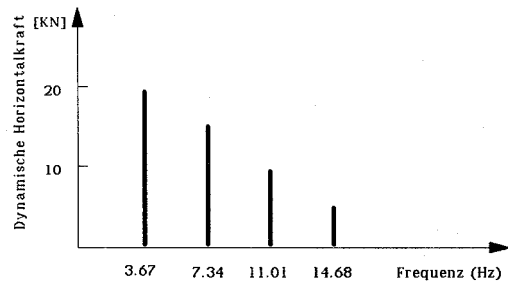
Fig. 1b Dynamic horizontal forces (assuming that 60 % of all weaving machines are in phase).

What has happened? The building had - before strengthening with steel trusses - a second eigenfrequency in the order of 3 Hz, i.e. slightly below the main horizontal excitation of the weaving machines (see Fig. 1b). With the steel trusses the horizontal eigenfrequency increased and matched exactly the main excitation. The horizontal vibration amplitude doubled.

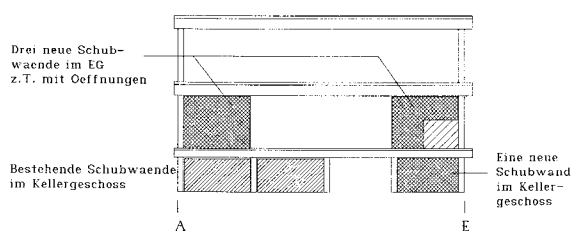
Fig. 1c Strengthening with four additional shear walls (cross section)

To cure the problem a dynamic FE analysis has been carried out to study the effects of three different strengthening layouts. Finally the solution shown in Fig.1c,d has been adopted. This solution carries the horizontal forces safely to the foundation and increases the eigenfrequencies and also the damping. The first horizontal eigenfrequency was calculated to be at 3.0 Hz, the second at 5.5 Hz. Thus the main excitation frequency of 3.67 Hz was between the two lowest frequencies and did not cause resonance. For higher excitation frequencies a coincidence with eigenfrequencies could of course not be excluded. A reduction of 80 % has been calculated for the frequency range of the main horizontal excitation (3.67 Hz). Measurements carried out after the strengthening showed that a reduction of slightly over 90 % has been achieved.

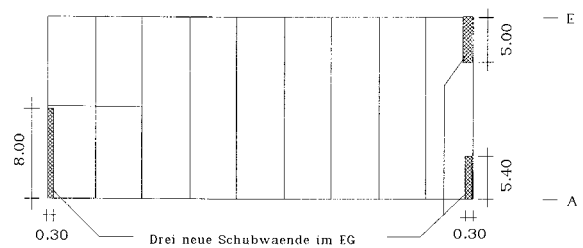
Fig. 1c Strengthening with four additional shear walls (plan view)

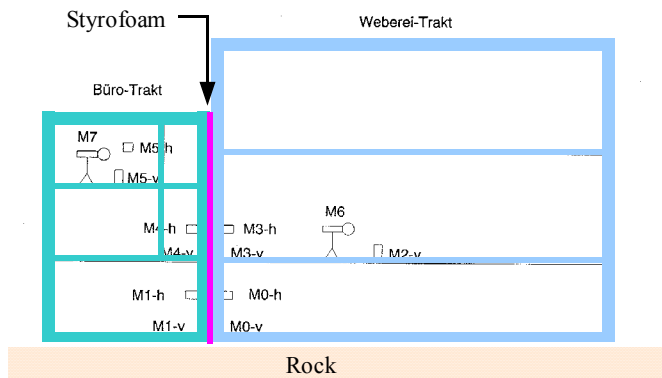
Fig. 2a Cross section of office building (left) and production building (right)

The two buildings have their foundation on the same rock layer, giving the vibrations a good transmission path from one building to the other. Furthermore the isolation between the two buildings consisted of a layer of Styrofoam having a thickness of 15 mm. Actually the wall of the already existing production building has been used as half of the formwork for the new office building.

- Remove the Styrofoam by use of a gigantic rope saw.
- Use elastic support for walls in office building
- Change the use of the office building

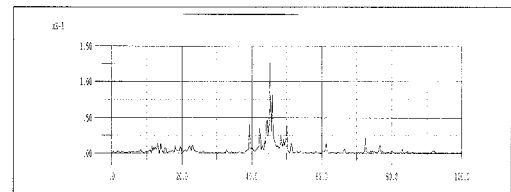
Fig. 2b Spectrum for vibration of wall in meeting room

Extensive vibration and sound measurements yielded the following results: The noise in the meeting rooms is clearly produced by structure borne sound. The spectrum of the sound pressure is – as can be seen from Fig. 2b to d – a superposition of the wall and floor vibration spectrum. The noise level in the meeting rooms was in the following range:

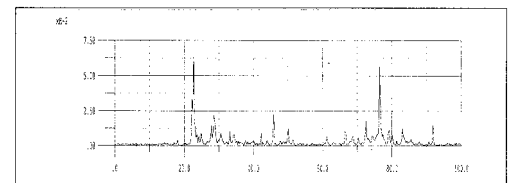
Fig. 2c Spectrum for vibration of floor in meeting room

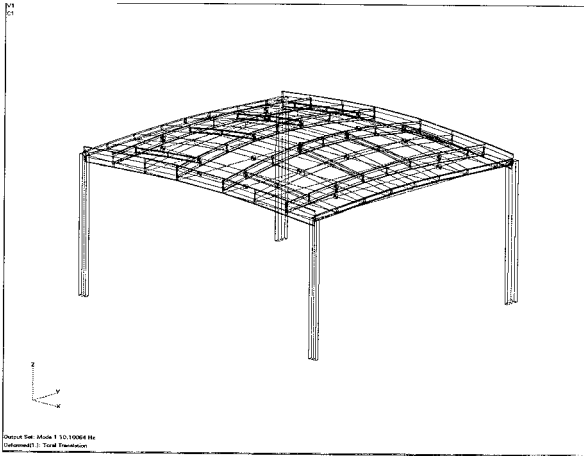
Four centrifuges have been installed on a platform resting on four steel columns as shown in Fig. 3a. The platform is a plate consisting of a concrete slab with 12 cm thickness resting on steel girders. The engineer designed the platform with the main frequency of the centrifuges in mind. With normal centrifuge operation of 600 rpm an excitation frequency of 10 Hz was assumed. For this excitation a platform having an eigenfrequency of 7 Hz was judged to be adequate. However already on the first test run the platform vibrated violently. Measurements yielded the response curve of Fig. 3.b and showed a maximum vertical amplitude of 13 mm/s (see Fig. 3.c). Clearly the eigenfrequency of the platform was not 7 Hz but rather 10 Hz and coincided with the main excitation.

Fig. 3a FE-Model for original centrifuge platform

The reason for the ill-behaviour of the platform is the contact between the concrete and the steel girders. The engineer assumed that the concrete plate and the steel girders act independently. This assumption is – at least for static consideration – on the safe side. For the dynamic consideration this assumption is wrong. The concrete slab sticks to the steel girders and acts therefore as a composite plate with a much higher inertia than the two elements considered separately. The concrete slab had thus an eigenfrequency of 10 Hz, which coincided with the main excitation frequency.

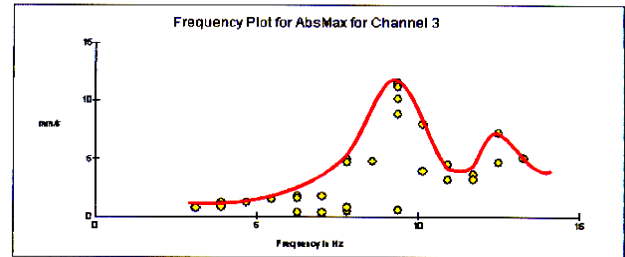
Fig. 3b Response curve of platform

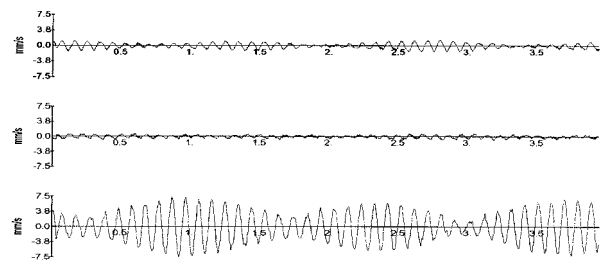
Fig. 3c Vibration measurement (hor1, hor2, vert) on platform

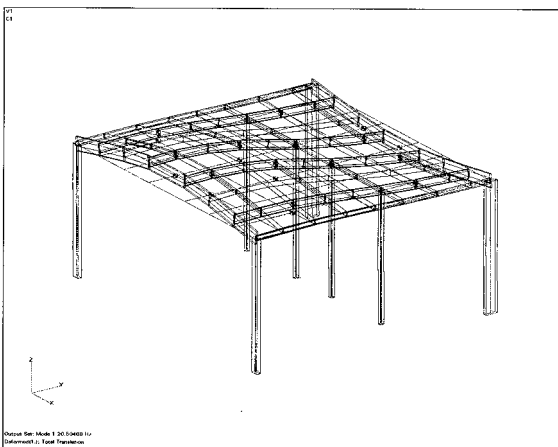
Fig. 3d FE-Model for strengthened centrifuge platform

The solution to the problem was the installation of four additional columns as shown in Fig. 3d. The fundamental eigenfrequency of the plate reached 20.5 Hz and no excessive vibrations could be felt.

- Original plate (no composite model): 7.5 Hz
- Original plate (with composite model): 10.1 Hz
- Plate with 4 additional columns: 20.5 Hz

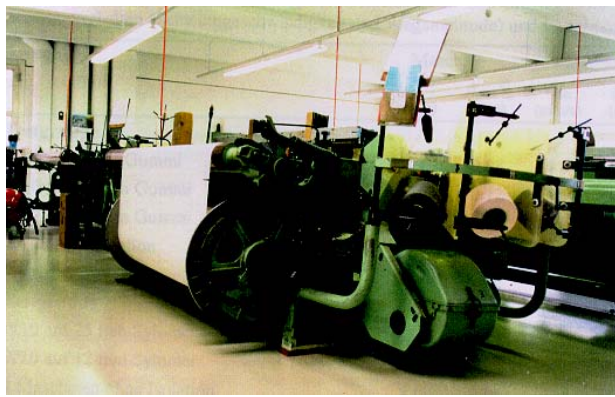
In the upper floor of a prefabricated industrial building 12 weaving machines have been installed, while the ground floor was still being used for repair and maintenance of heavy trucks. With the onset of the weaving activity, people working in the ground floor complained about the noise level. With all weaving machines in operation a noise level of 80 dBA has been measured in the ground floor. This level is – even for a truck repair shop – not really acceptable.

Fig. 4a Weaving machines in the upper storey

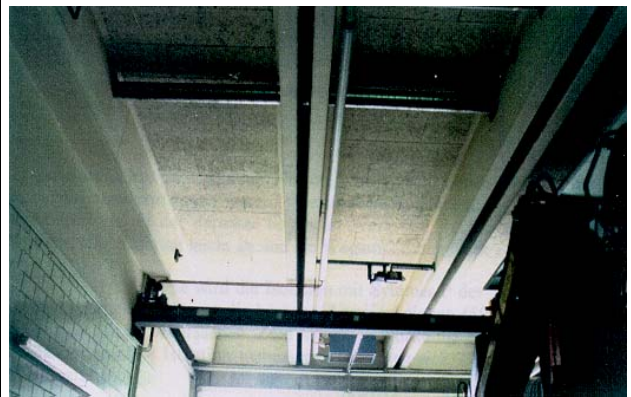
Fig. 4b View of the prefabricated ceiling from the ground floor

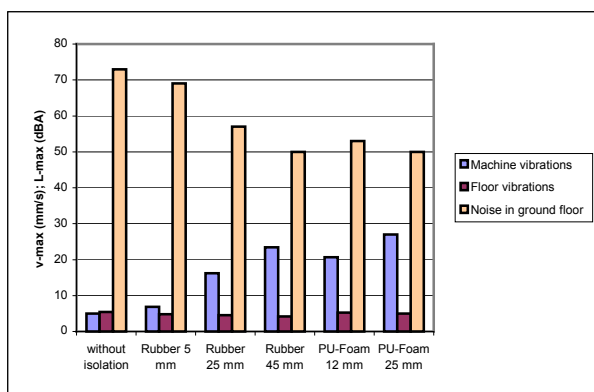
Fig. 4c Effect of different rubber and PU-foam pads

A more effective solution was to use rubber or PU-foam pads. They are easy to install and do not cost a fortune. Furthermore tests can be carried out without much effort until the right level of “softness” is reached. As can be seen from Fig. 4c the vibrations of the weaving machine increase with increasing softness of the pads, while the noise level in the ground floor decreases. The vibrations of the floor did – in this case – not vary much. The task was thus to chose the right compromise between noise reduction and increase of machine vibration. Finally the solution with 12 mm PU-foam from SYLOMER has been adopted. The vibration level of the floor (prefabricated, pre-stressed elements) with 5 mm/s maximum velocity and 0.1 mm displacement amplitude was well within the acceptable limits.

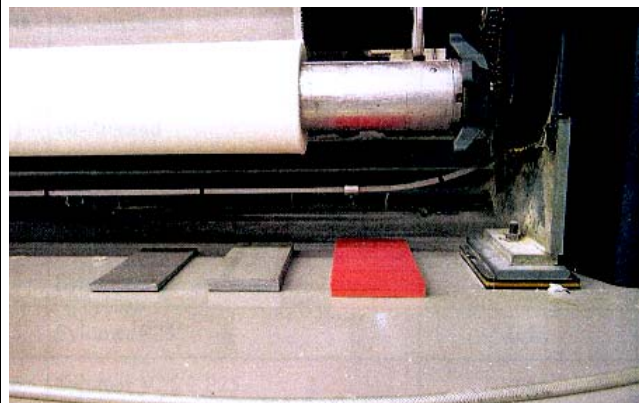
Fig. 4d Samples of rubber and PU-foam pads

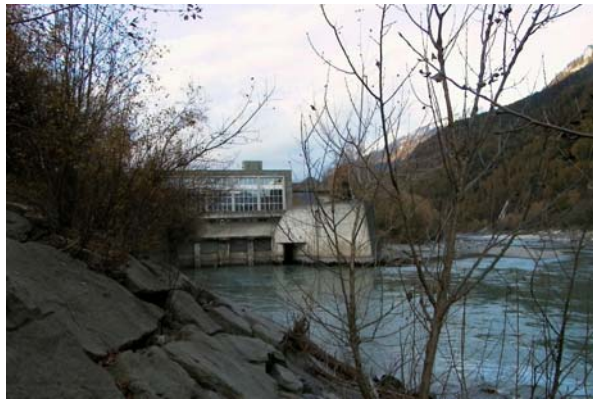
Fig. 5a Hydro power station

With a distance of approximately 100 m to the hydro power station the architect did not expect, that vibrations from the turbines could cause any problems in the house he was designing on the other side of the motorway. However his client is now complaining about a constant noise which causes sickness and headache and does not let him sleep during the night.

Measurements at the foundation of the hydro power station showed a constant vibration of 0.15 mm/s. In a distance of 100 m the vibration at the foundation was still at 0.025 mm/s. Due to amplification values between 0.05 and 0.13 mm/s at 31 Hz are measured in the house. With a radiation efficiency of 10 dB this converts to 31 to 39 dBA, a value not very comfortable during night time.

The reason for this unexpected strong transmission is the concrete underpass. Vibrations are transmitted with very little damping from the power station to the house. During construction an isolating layer should have been installed at foundation level.

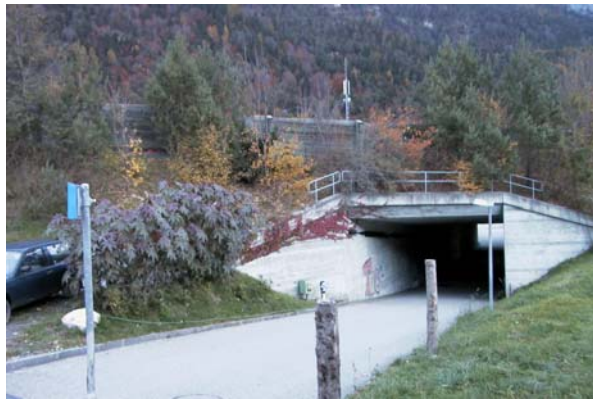
Fig. 5b Concrete underpass

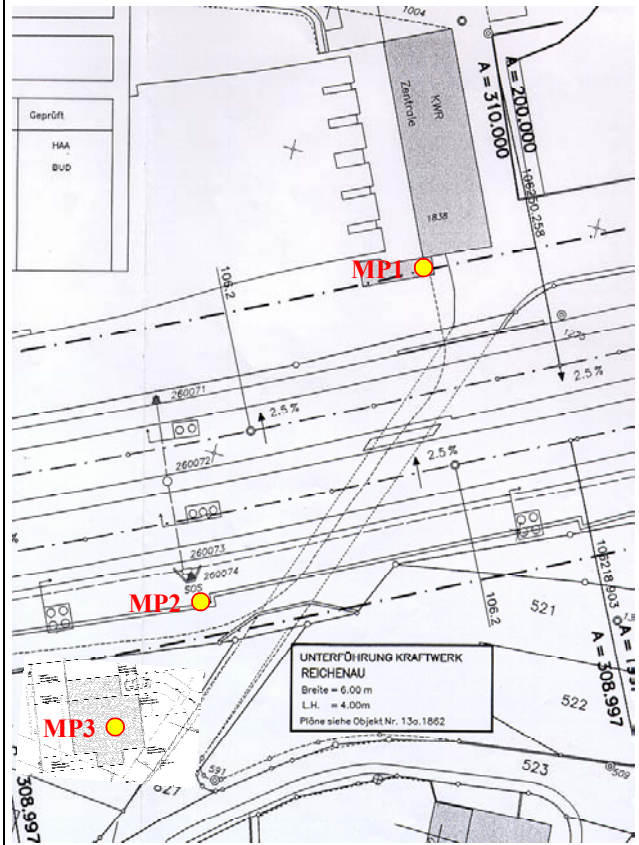
Fig. 5c Plan of hydro power station, underpass and affected building

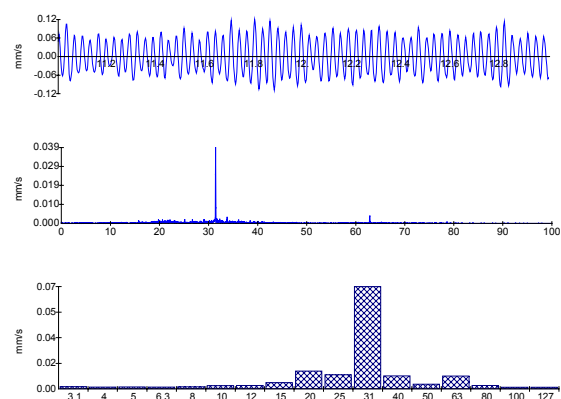
Fig. 5e Floor vibrations in building

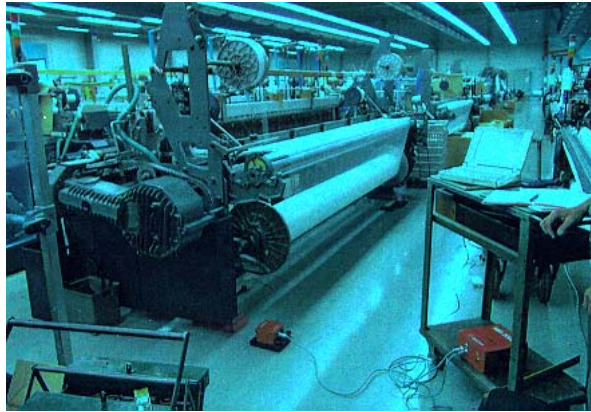
Fig. 6a Vibration measurement under weaving machine

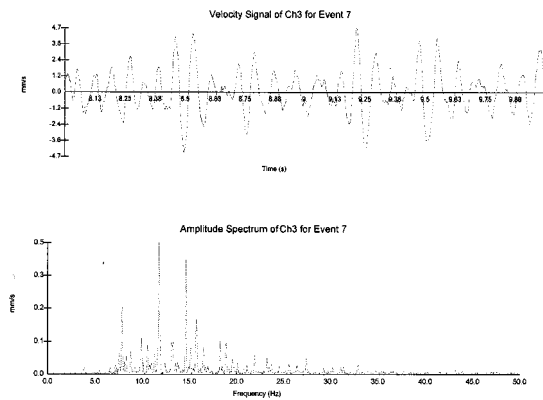
Fig. 6b Vibration time history and amplitude spectrum

To understand this behaviour we have to know that the floor had an eigenfrequency of 12 Hz. The main excitation of the weaving machine is – as can be seen in Fig. 6b - at 8, 12 and 15 Hz. With increasing thickness of the isolation pads the dominant excitation shifts from 15 to 12 Hz leading to resonance with the eigenfrequency of the floor. With pad thickness in excess of 50 mm the dominant frequency shifts towards 8 Hz bringing the excitation out of resonance.

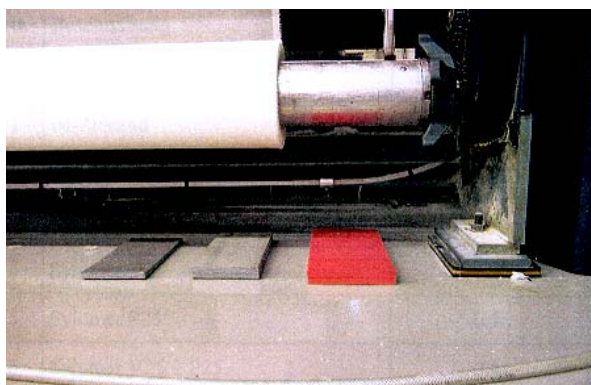
Fig. 6c Samples of different isolation pads

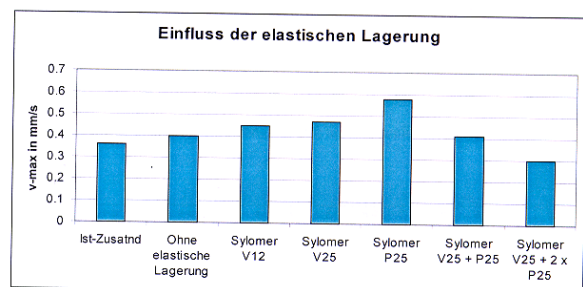
The machines were initially mounted on relatively stiff rubber pads. It was assumed that softer pads should bring some reduction in floor vibration. However - as can be seen in Fig. 6d - the vibrations increased with increasing thickness. Only with a layer thickness of 75 mm a reduction could be achieved. This layer thickness was however not acceptable for the machine operation. Thus the original pads were maintained and the vibration of 4 mm/s has to be tolerated.

Fig. 6d Influence of isolation pads with different thickness

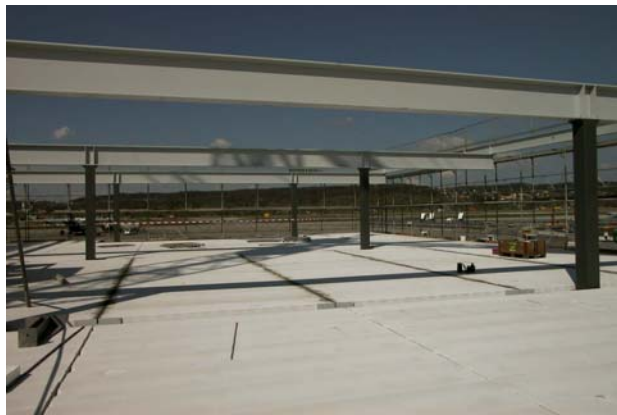
Light-weight concrete is for many applications an ideal material. Care has to be taken however if it is used for structures susceptible to vibrations. The engineer designing the bus terminal in Fig. 7a was aware of this problem and argued that post-tensioning would increase the eigenfrequency of the floor slab. The post-tensioning had already been applied to part of the floor, when mechanical difficulties cropped up. It was decided that the effect of post-tensioning should be verified by measurements.

Fig. 7a Light-weight concrete floor slab for bus terminal

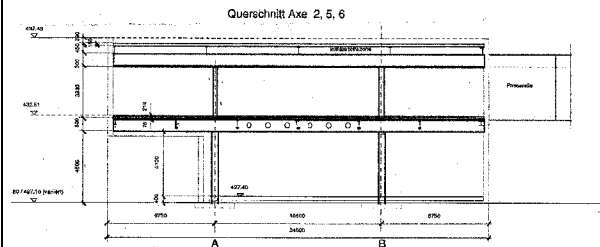
Fig. 7b Cross section of bus terminal

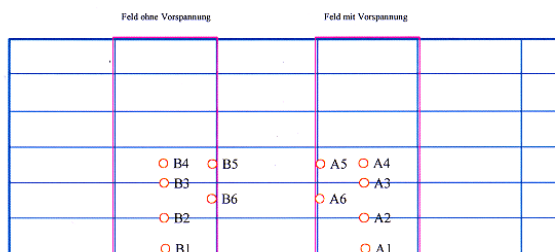
Measurements have been carried out in a systematic way, as shown in Fig. 7c. In Fig. 7d and 7e the vibration time history and the corresponding amplitude spectrum are compared for the section without post-tensioning with the post-tensioned section. Obviously the vibration time histories are virtually identical and also the main frequencies of the two systems exhibit only minor differences.

Fig. 7c Plan view with position of vibration sensors

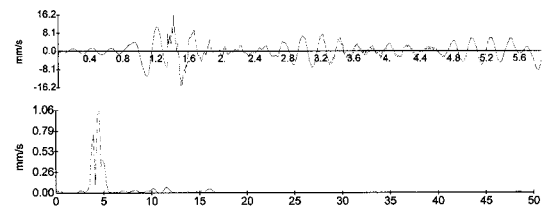
Fig. 7d Vibration time history and amplitude spectrum for section without post-tensioning

Post-tensioning (and also pre-stressing) in itself does not affect the eigenfrequency of a structure. This is due to the fact that the applied forces are internal forces. However due to the closing of cracks a slight increase in eigenfrequency can be observed. In the example above an increase of 8% has been observed.

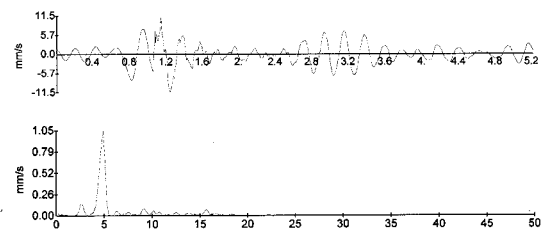
Fig. 7e Vibration time history and amplitude spectrum for post-tensioned section

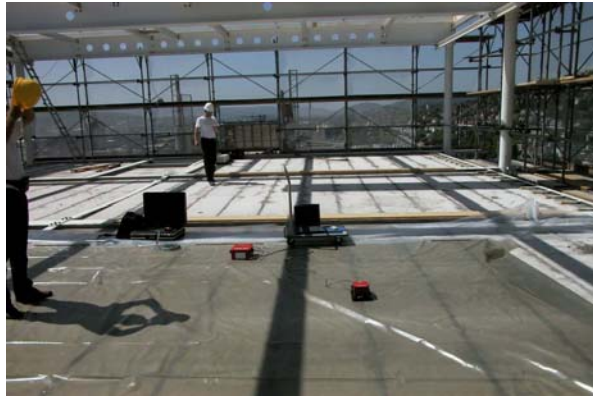
The two top floors in the 15 storey building had to be built – for several reasons – in light-weight concrete. Vibration measurements during construction showed that the vertical eigenfrequencies were between 5.9 and 6.1 Hz. For the intended use as office space the dynamic behaviour of the floor seemed perfect.

Fig. 8a Light-weight concrete floor slab in construction

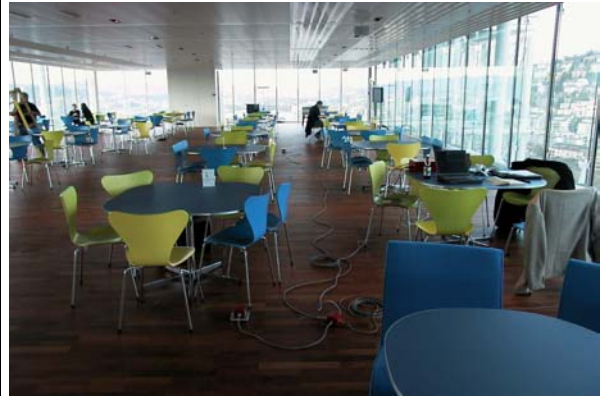
Fig. 8b Canteen with light-weight concrete floor shown left

After completion of the building the top floor with its magnificent view was converted into a canteen. In a canteen the movement of people is somewhat more frequent than in ordinary office space and people sitting at a desk wondered about the vibrations of the floor. Measurements carried out in the canteen proved that the eigenfrequency of the floor was still between 5.2 and 5.4 Hz, a value which is perfectly appropriate for a restaurant. The peak velocities however were in the order of 2 to 5 mm/s and reached – when a person was running through the canteen - values of 8.5 mm/s (Fig. 8c)..

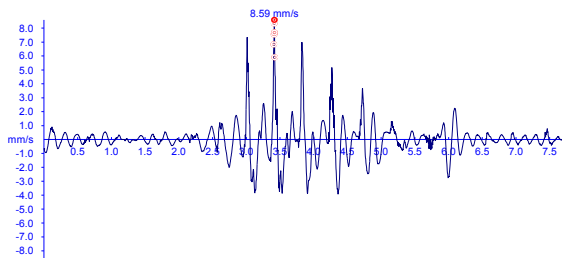
Fig. 8c Vibration time history

Light-weight concrete slabs are susceptible to vibrations. Due to their low unit mass impulsive excitations can induce considerable vibrations. For normal concrete slabs a check of the eigenfrequency is in most cases sufficient, as only harmonic excitation can lead to excessive vibrations. For light-weight concrete slabs in addition a check of the behaviour under impulsive excitation – like the steps of a running person - should be included.

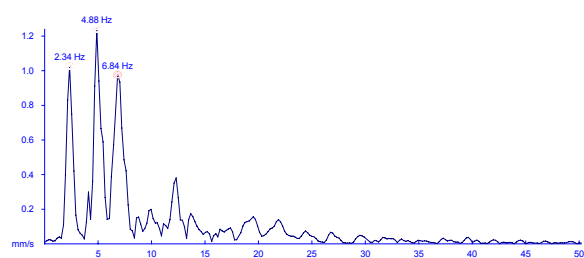
Fig. 8d Amplitude spectrum for signal in Fig. 8c

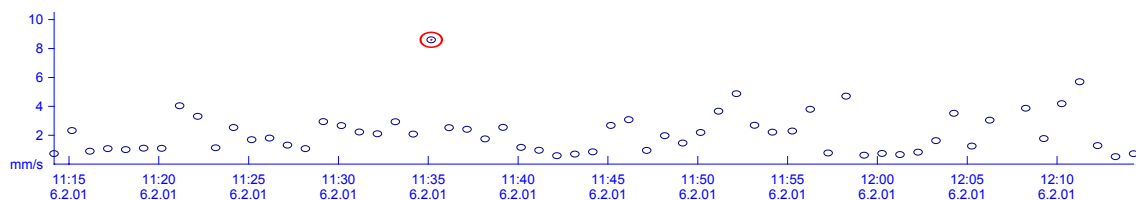
Fig. 8e Peak velocities recorded during one hour

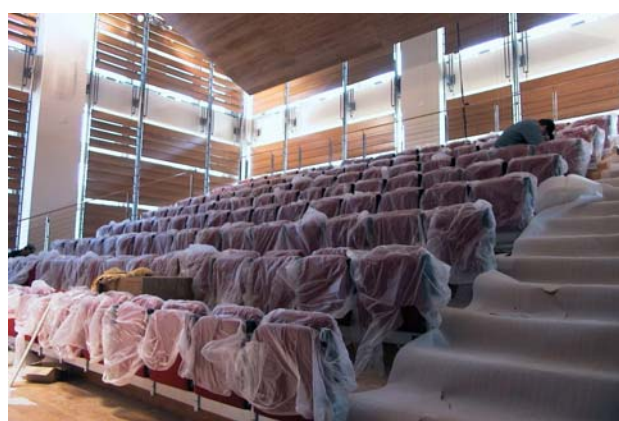
The Aula shown in Fig. 9a is designed as a rectangular inclined cantilever platform. The platform rises at an angle of some 20° from the front row to the top row. The lower edge (with the front row) is clamped into a foundation block (below the floor) while the other three edges of the platform are free. The width of the platform is in the order of 10 m, the length of the platform (in the direction of the cantilever beams) approximately 8 m.

Fig. 9a Seat rows on cantilevered platform

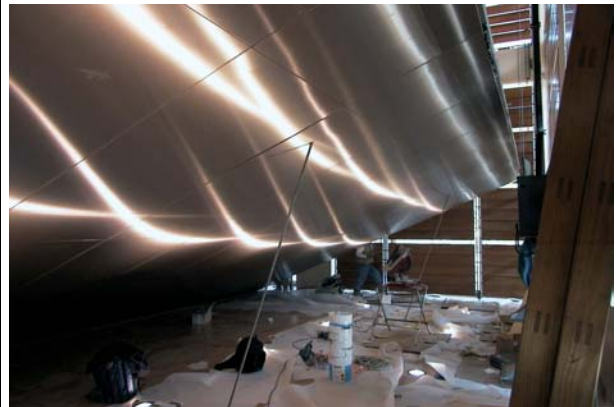
The platform showed considerable vibrations, which made it necessary to install two tension cables between the free edge of the cantilever platform and the floor beneath (see Fig. 9b). With these two pre-stressed cables the system should be stiffened and the vibrations reduced.

Fig. 9b Rear view; 2 tension cables between the free edge of the cantilever platform and the floor beneath stiffen the system.

It should be noted that the pre-stressing forces of the tension cables have no influence on the dynamic behaviour of the cantilever platform. It is only the cross section of the cables and the E-modulus of the steel that enters the equation of motion. Comparing the small cross section of the cables with the huge cross section of the cantilever we cannot expect too much from these cables.

One solution to the problem is to install damping elements at the lower end of the tension cables. Care has to be taken that no slip exists in these damping elements. For moderate excitation the relevant displacements are in the order of 0.2 mm. Ordinary dampers have a slip in excess of this and would not be effective. Another possibility is the installation of tuned dampers.

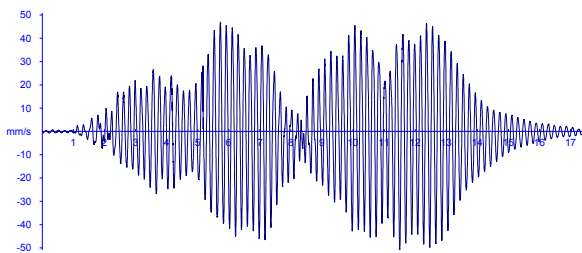
Measurements carried out after the installation of the tension cables showed that the eigenfrequency has increased somewhat but that the vibrations were still considerable. With three persons exciting the platform purposely at resonance maximum velocities of 50 mm/s could be achieved. This corresponds to a maximum acceleration of 2 m/s^2 or a displacement amplitude of 2 mm.

Fig. 9c Vibration time history due to harmonic excitation by 3 persons

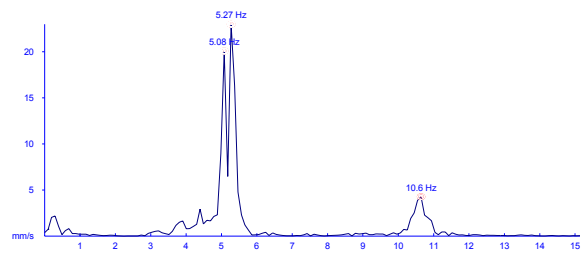
Fig. 9d Amplitude spectrum for signal in Fig. 8c

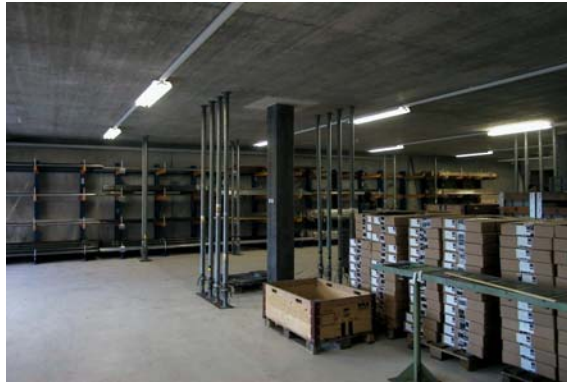
Fig. 10a Test with eight struts near each column to achieve doubling of eigenfrequency

One proposal was to decrease the free span between the columns. As an experiment to prove the appropriateness of this solution eight steel struts have been installed close to each column (giving a total of some 120 struts). It was argued that the actual span of 8.0 m would be reduced to 5.6 m. Given the fact that the eigenfrequency is proportional to $1/L^2$ the frequency would increase from 14 Hz to 28 Hz.

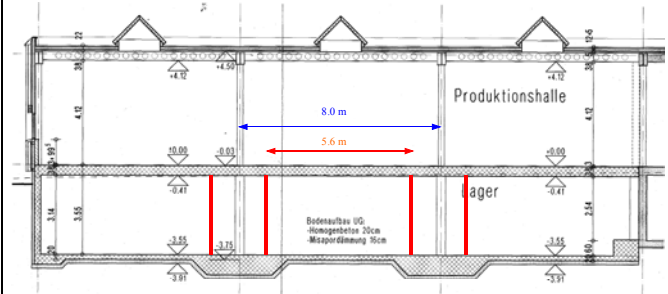
Fig. 10b Section with proposed struts to reduce free span from 8.0 m to 5.6 m in order to increase eigenfrequency from 14 Hz to 28 Hz

A close look at the proposal in Fig.10b should reveal that this method cannot be successful. The steel struts with a cross section of 7 cm^2 are much weaker than the existing columns. They act more like soft springs giving a slight increase to the fundamental frequency. Measurements proved that the increase was not more than 1 Hz.

It should be noted that very substantial cross sections are needed to stiffen an existing structure which has already considerable stiffness. In the case of a concrete slab with 40 cm thickness we cannot expect that steel rods with 7 cm^2 cross section will bring about much change.

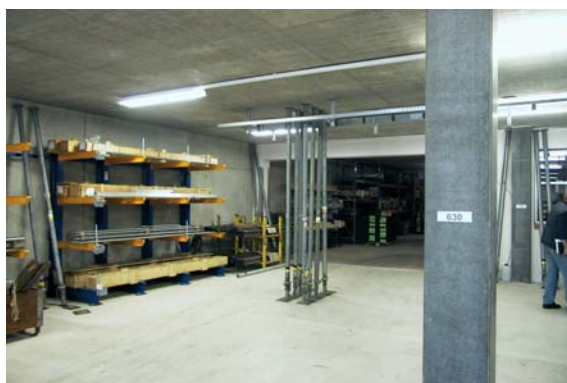
Fig. 10c Test with eight struts in midspan to achieve an increase from 14 Hz to 18 Hz

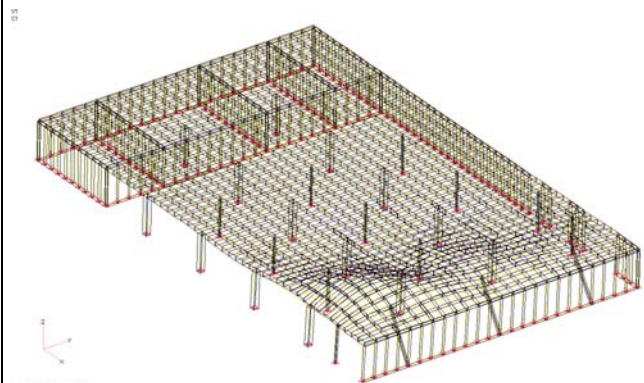
Fig. 10d Dynamic FE-model to simulate effect of strengthening with additional columns.

For the development of dynamic strengthening it is imperative to use simulation with FE analysis as shown for instance in Fig. 10d. Our imagination is in general quite good enough to assess the sizing for a static problem. But for a dynamic problem we are in most cases at a loss.
